Fitness for Service: Using NDT and Inspection

BS 7910, API 579 methodology

Paresh Haribhakti
MD TCR Advanced

Isomerization reactor

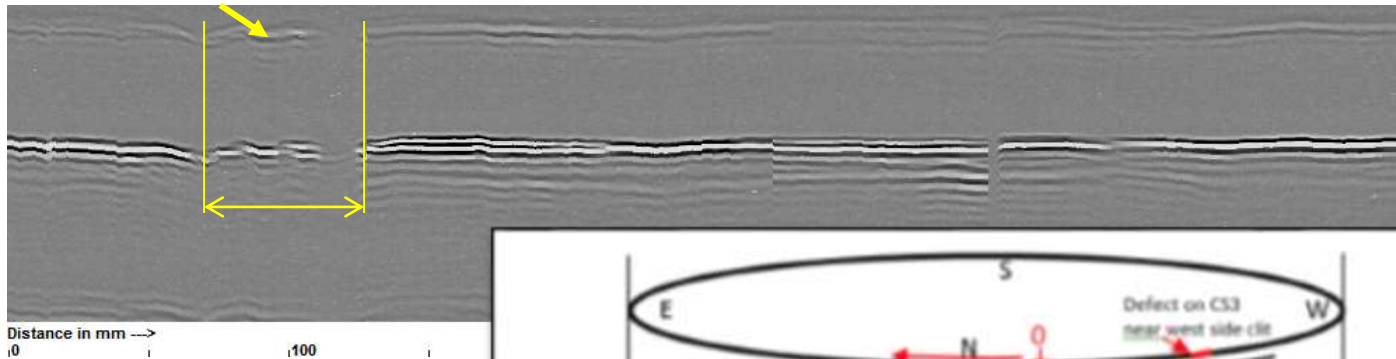
Extent of coverage: CS2 – CS5, LS1 – LS3, All Tee Joints

Drop in back wall echo with indication of flaw

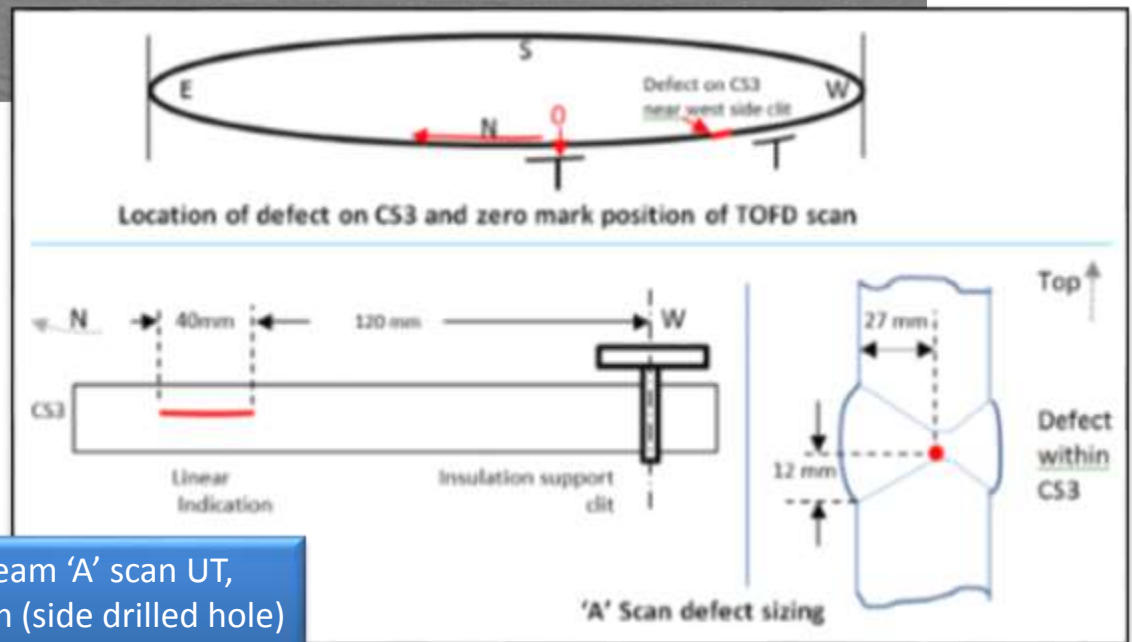
Defect sizing by angle beam 'A' scan UT, size equivalent to $\varnothing 4\text{mm}$ (side drilled hole) and 40 mm length

- Any flaw of less than 11mm x 220mm is Safe
- Flaw existing at CS3 has size of SDH \varnothing 4mm x 40mm
- The existing flaw size is less than critical flaw size
- The defect located at CS3 is innocuous to continued safe operation of the reactor

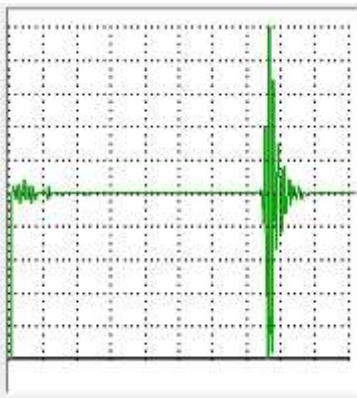
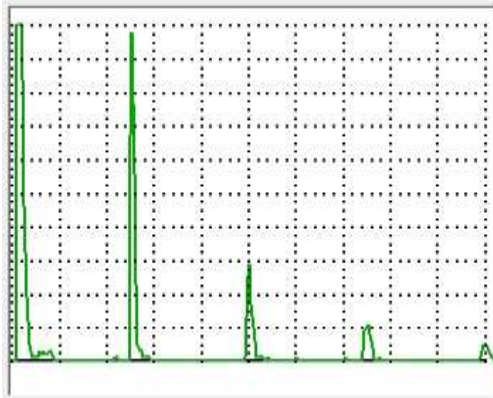
AUBT
Echo pattern at Shell 2

- Extent of coverage: First four shells: 100% scanned with 10% probe overlapping method
- Probes: 10 MHz
- References: (1) Guideline from API 941 (2) Comparison with away region
- No indication of HTHA observed anywhere

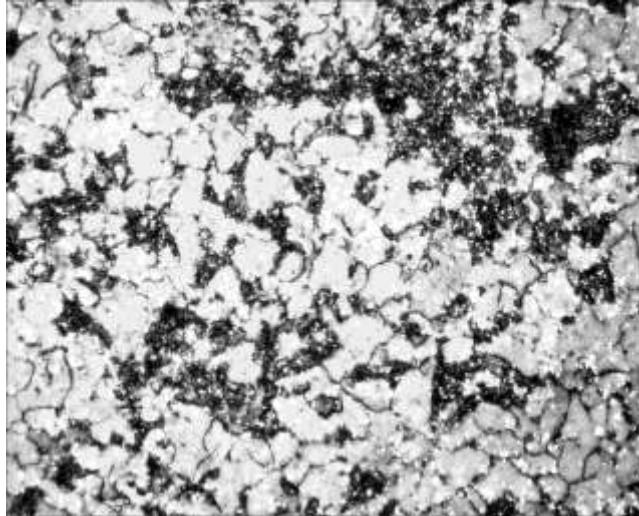
Structure at Shell 2

- Extent of coverage: Total 60 Locations (*Shell 2 : 16 locations*)
- Method: ASTM E1351 “Practice for production and evaluation of field metallographic replicas”
- Etching technique: Manual swabbing with 2% nital
- No significant change in microstructure is observed, microstructures show ferrite and pearlite structure. ASTM Grain size 9 to 10. No indication of pearlite degradation.
- **Heat excursion on external surface of shell is insignificant**

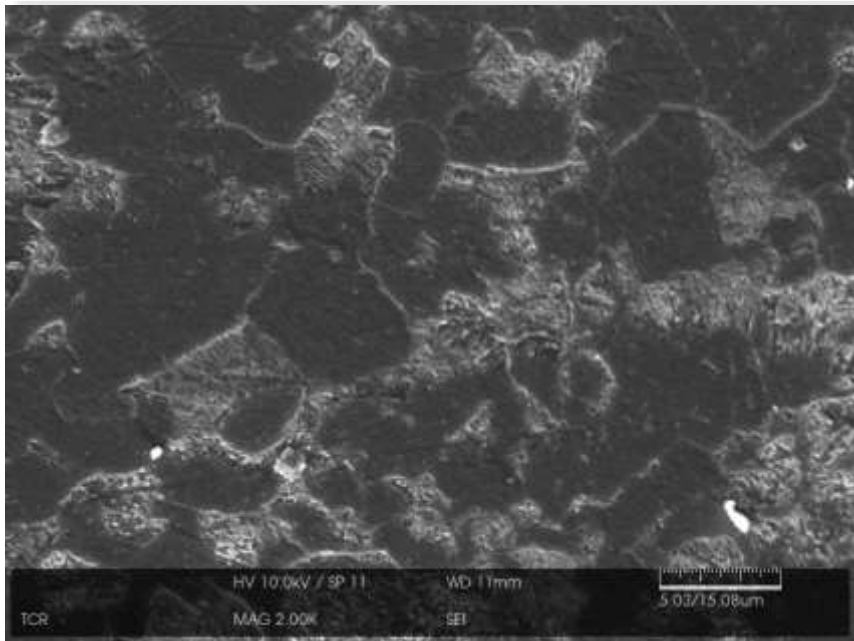
Structure from Shell 2

- Extent of coverage: 15% of replicated structures
- Magnification up to 3500X after Gold coating of replica
- Finding: Fine grained ferrite and pearlite structures
No significant difference in structures
