Fitness for Service: Using NDT and Inspection

BS 7910, API 579 methodology

Paresh Haribhakti
MD TCR Advanced

Isomerization reactor

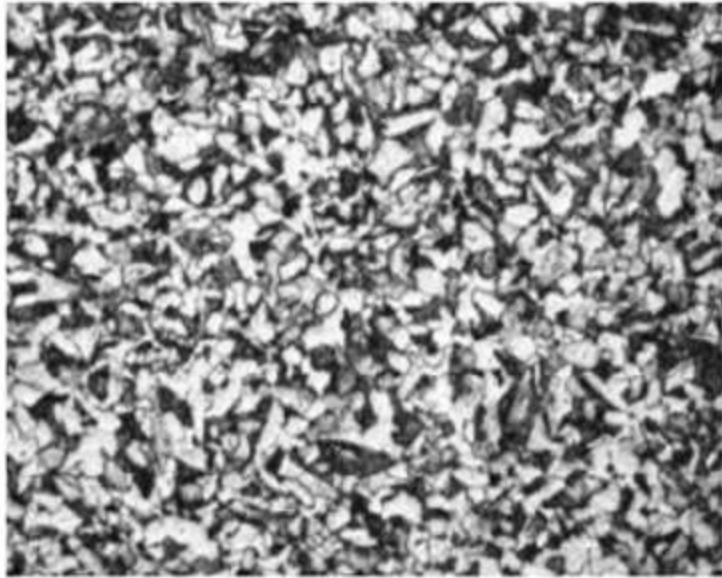
Normal structure

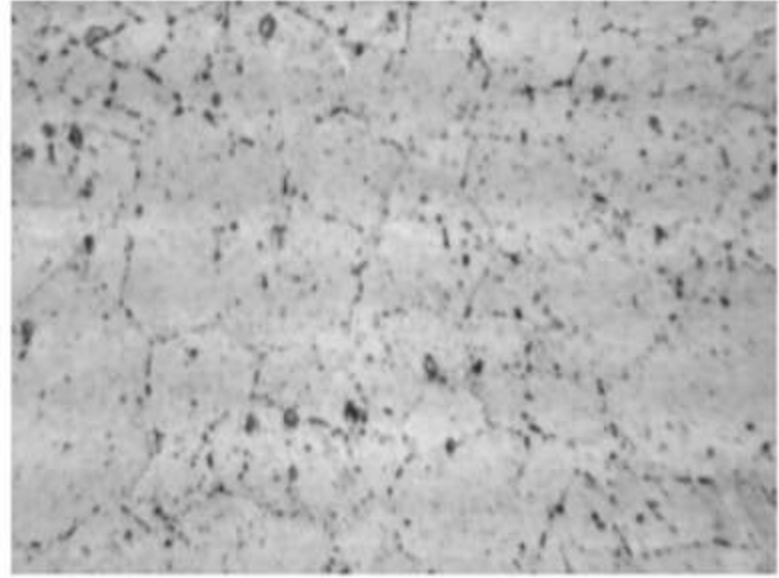
- SA516 Grade 70 in normalized conditions has of ferrite and pearlite
- Reactor shell may undergo transformation of phases if the local temperature excursion exceeds 723°C
- Pearlite gets spherodized resulting in reduction of strength

Spherodized pearlite

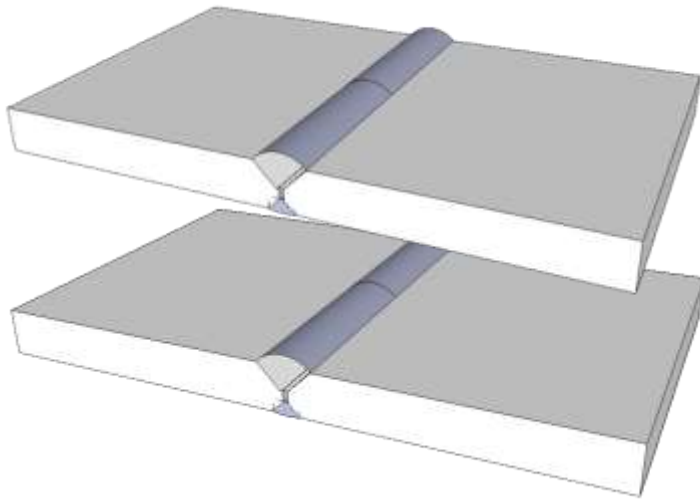
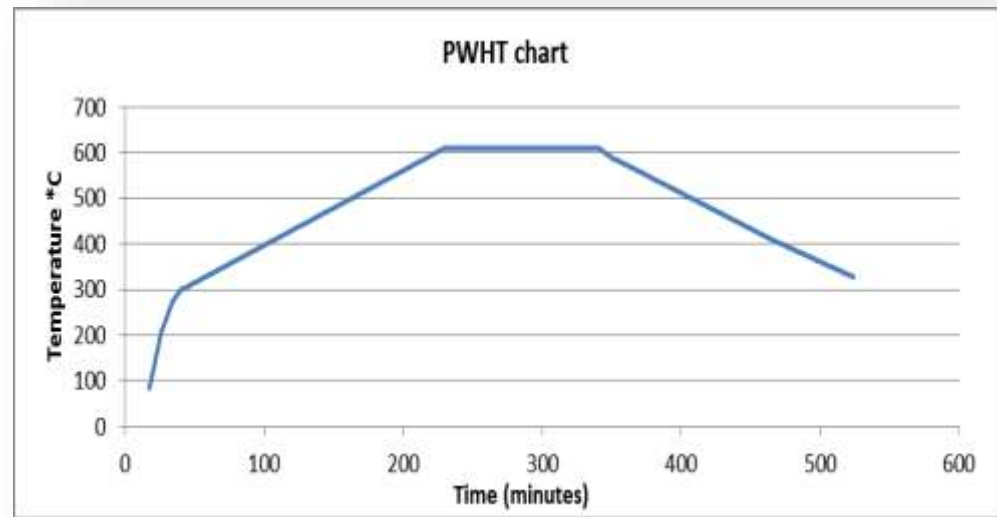
Welded coupon placed on heater coil

Covered with 45mm thick hot insulation

Control cooling to simulate actual heat excursion

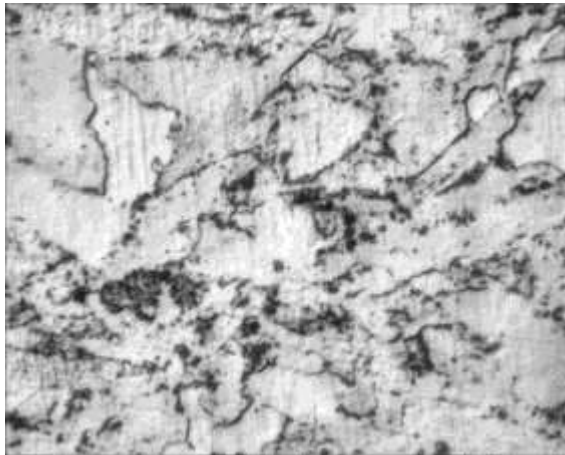
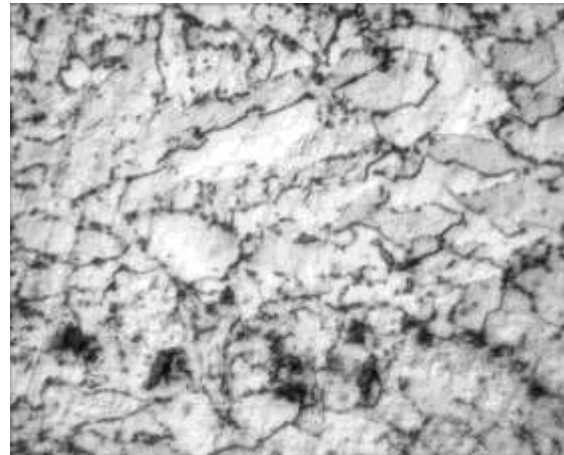
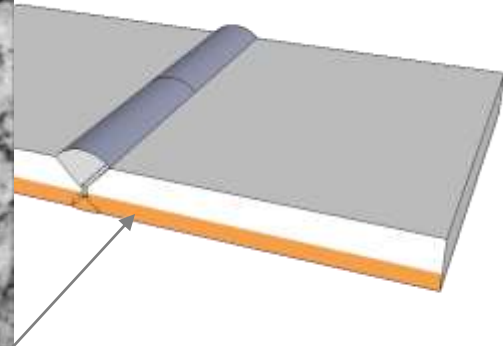
- Microstructure are of ferrite and pearlite.
- No significant change in grain size after simulated heat excursion.
- Minor effect of spherodization of pearlite.
- No significant change in microstructural properties after short period temperature excursion up to 710°C

PWHT Coupon

PWHT + Heat simulated coupon (*Bottom*)

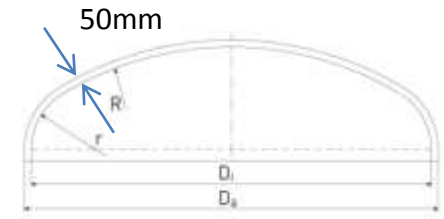
The available thickness of elliptical head of 50 mm is higher than the minimum required thickness of 28.55 mm.

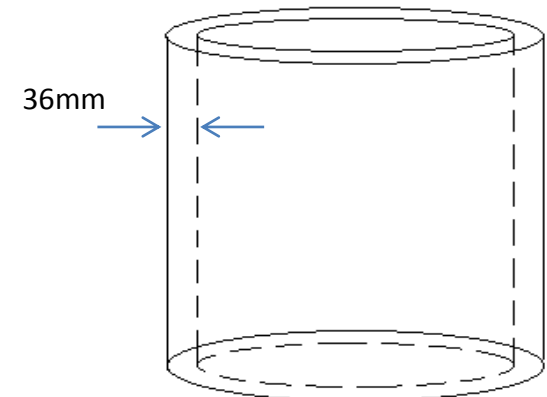
Fracture toughness calculation for assessment of crack like flaw in weld

- Any flaw of less than 11mm x 220mm is Safe
- Flaw existing at CS3 has size of SDH \varnothing 4mm x 40mm
- The existing flaw size is less than critical flaw size
- The defect located at CS3 is innocuous to continued safe operation of the reactor
